Case Study 8

T. Bob Davis, DMD

CASE REPORT – INSTALLMENT #8

BILL J. – Heavy Bruxer

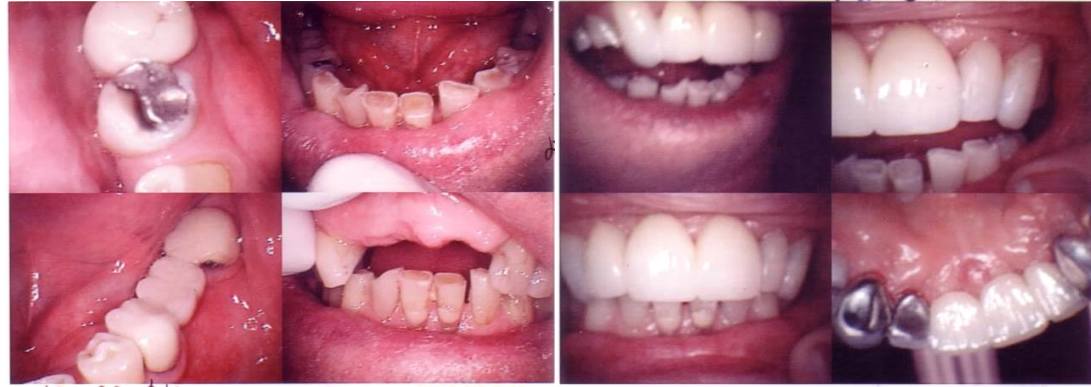
Bill (No night guard Grinder/clencher). Remade but also MADE patient accept and wear nightly a new nightguard. The case has lasted over 13 years now with nightguard and total of 16yrs of Maryland Bridge service..

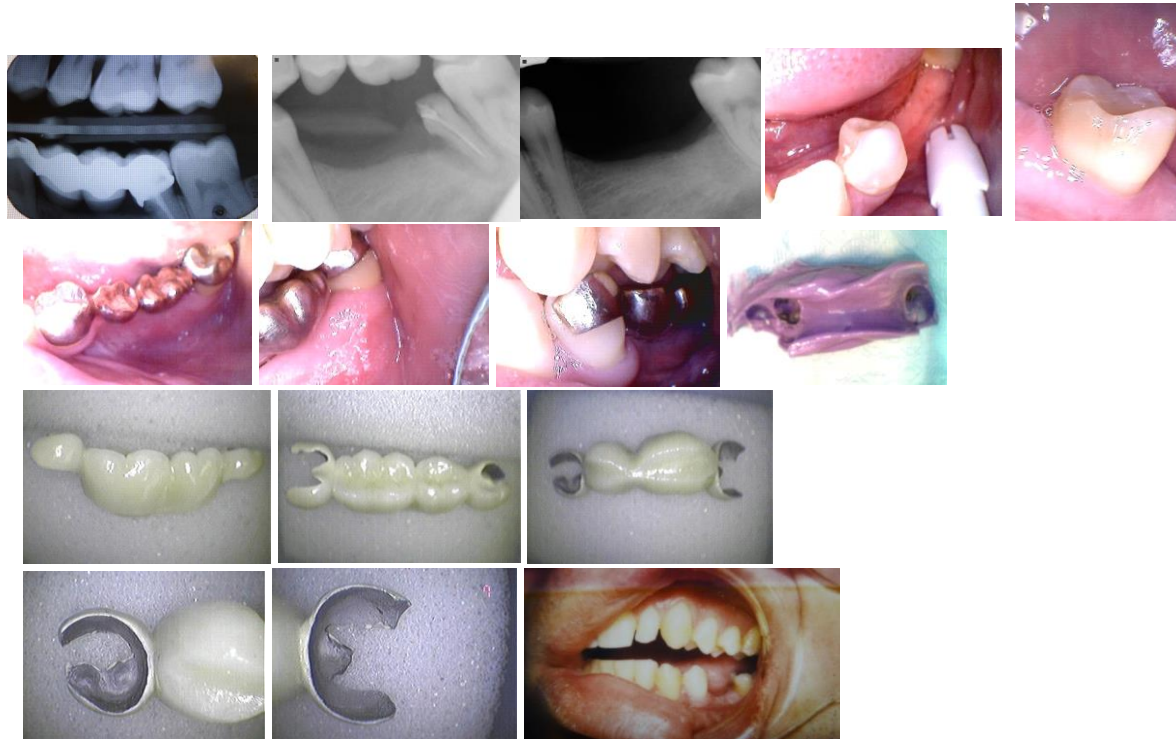
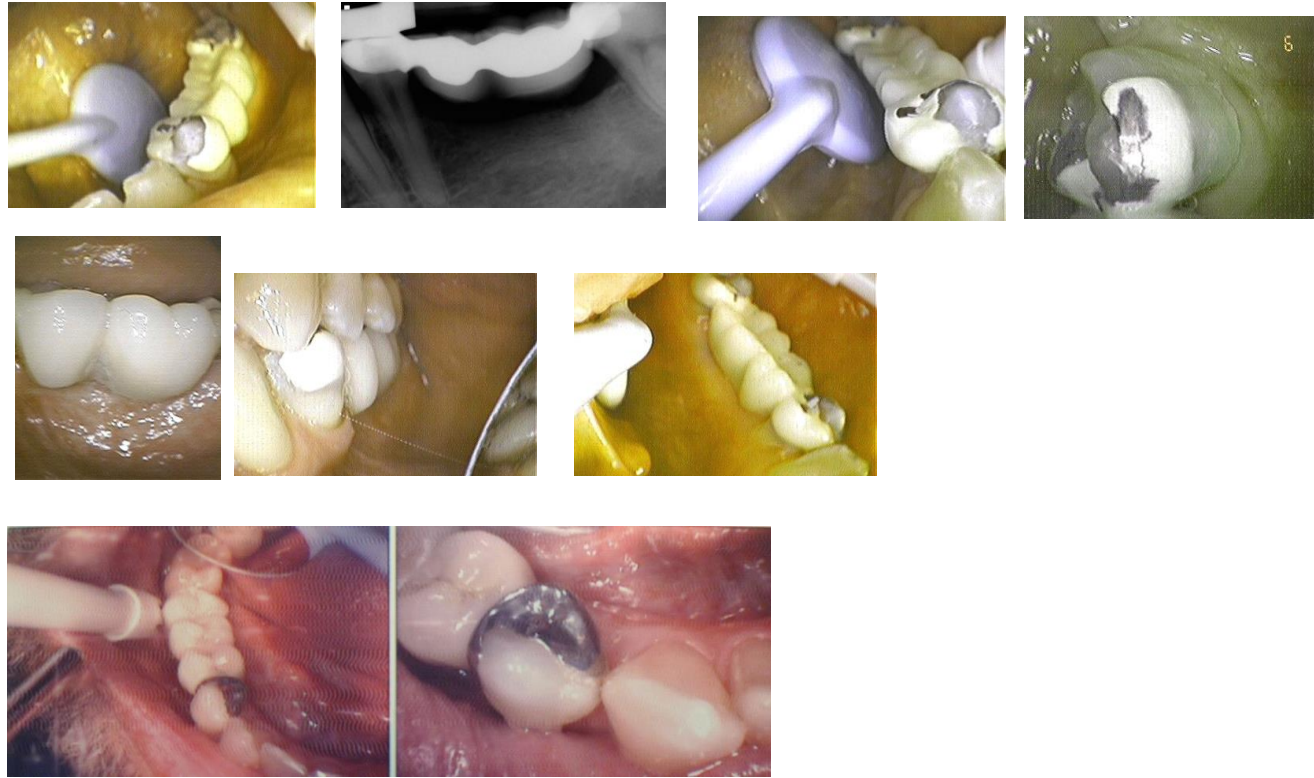
3/25/86 STEVE S.

At age 24, in 1983, the retained D 11 was extracted and #19 was very sensitive due to probable pulp cap as a teenager. His MB replacing #20 was a standard design. #19 had DOL amalgam, large and deep. The mesial, facial and lingual -mesial were solid enamel surfaces. Thus in 1985, ample enamel for a MB was present. Unfortunately he was a clincher/grinder and a nightguard was delivered while waiting on seating the MB. That greatly relieved his headaches. Thus the MB was seated with Comspan . Four months later, #19 died and had a root canal done, completed in 1986. The MB debonded and was rebounded with Comspan. In 1988, 2 years later, the distal Amalgam broke and we prepared a reverse $\frac{3}{4}$ crown and used Rexillum III, etched and bonded with Comspan to the tooth portions not covered by the MB wings and occlusal rest. Fifteen years after the first MB was seated, the mesial root of #19 failed and was extracted. The distal root was healthy and a full crown was prepared for a combo MB. The crown was seated with ZnPO₄ and MB wings with RelyX ARC, January 2000. A decade of service ended with the distal root cracked and perio abscessed. Extracted with the MB wings still totally attached to the bicuspid (had to be debonded). After a period of healing, a standard prep for #18 and no changes to #21, a new standard design MB was bonded to #18 & #21 with RelyX ARC. Over 32 years of MB service!

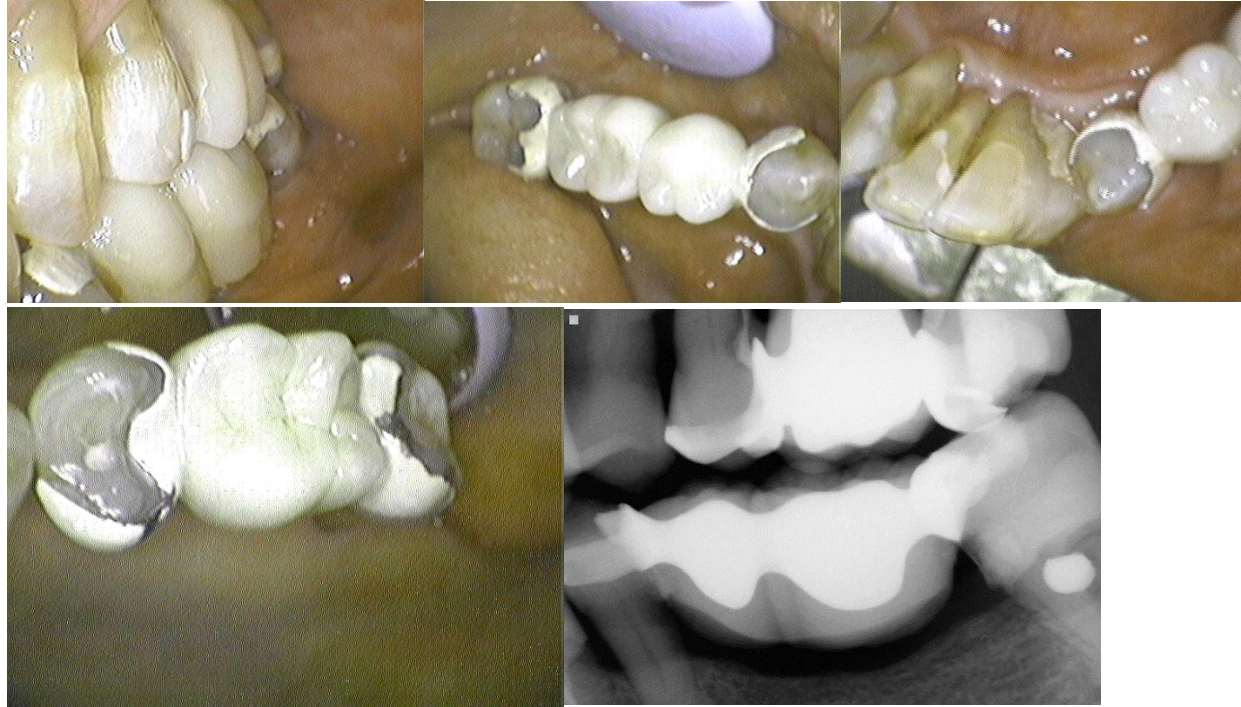
5/28/87 ROSCO M.

A gentleman whose early years led to severe perio disease, ultimately maintained by a periodontist and myself, and whose later years have been fraught with complications from erratic home care plus traumatic eating habits. This is a case that demonstrates how teeth that others would remove and place dentures can be maintained in spite of severe perio, crowding and rotations.

It began in 1987 with a MB 18x20 replacing 19. In 17 years the patient split #20 on peanut brittle and we lost #20 as an abutment. Thus, 18x21 became our new MB in 2004. He is now experiencing 27 years of MB service.

#14 became a split down the middle fractured in half tooth in 2002. A MB 13x15 was seated with RelyX and resealed in 2005 and 2006. The patient was under extreme stress health wise and lost his wife after her lengthy illness. Clinching was the cause of several chipped and broken teeth as well as the MB debond. As of 6/23/10, he is very happy and comfortable with both MB's on his left side.

As a post note, look at the bonding together of #22/23 in an effort to keep his loose front teeth in his twilight years.
