Case Study 11

T. Bob Davis, DMD

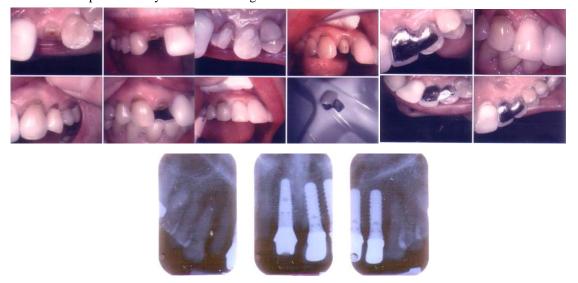
BOB H. – This patient arrived in our practice with periodontal disease, mobile loose teeth, especially #7, and lots of decay. We reestablished periodontal health over time and did full mouth rehabilitation. #7 was crowned on a core build-up with porcelain fused to metal crown and a MB wings low down on the lingual gingival thirds of #6 and #8. This periodontal stabilization lasted from 2/23/1983 until 8/30/2005, 22 years with one rebond of #8 on 10/20/1984 and #6 on 8/7/1992. In 2005, I replaced system with s ingle porcelain fused to metal crown #7 without wings due to perio stability. No more mobility! Mission accomplished! Point made! Stabilization works! MB wings can fit every periodontists' need for select cases! Note mirror view of lingual wings and crown – also beautiful esthetics of #7 crown facially. 22 years success until no longer needed!

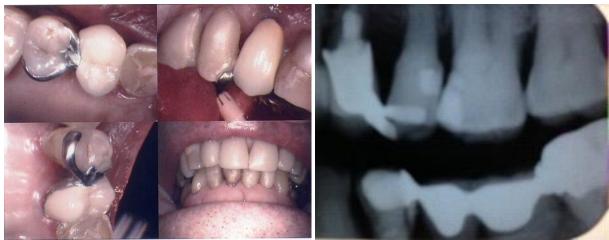
Mr. C. at age 89 had a very short root and long crown on #12 that was mobile. By attaching a MB wing on the healthy and stable tooth #13 we were able to maintain #12 safely for eight years later.
