Case Study 6

T. Bob Davis, DMD

**CASE REPORT – INSTALLMENT #6
HOMER C. Posterior Long Span (2 or more pontics)**

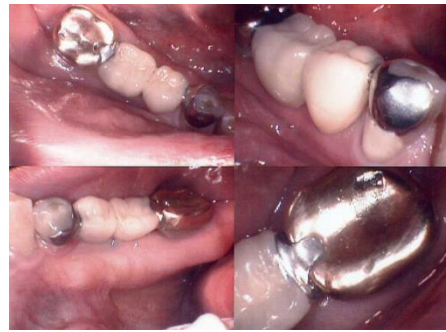
Two Maryland Bridges were made for Mr. C. within eight months of each other. The lower right #28 to #31 (two pontics) and lower left #18 to #21 (two pontics) were placed in October 1987 and May 1988, with Comspan resin cement. Both had given 22 years of uninterrupted service.

At the end of 22 years, the patient was grinding/clenching his teeth overnight and awoke with a broken #28 at the gum line. The MB wing was totally secure onto the buccal and lingual and distal/occlusal of #28, no debond. Failure came at the gumline due to years of severe

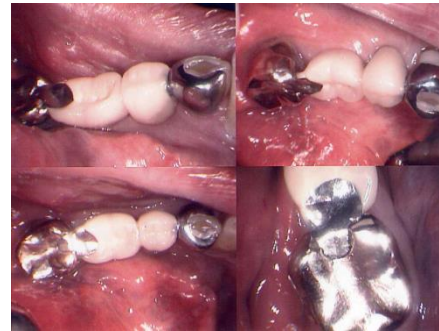
Fabricated first two by Bo Braze Lab, seated with Comspan. Newest one by Highland Lab and seated with RelyX ARC. Due to debilitating age conditions, patient was unable to continue normal hygiene and regular hygiene dental office appointments. However, the work remained intact and functional without the high costs of implants or hassle of a removable partial.

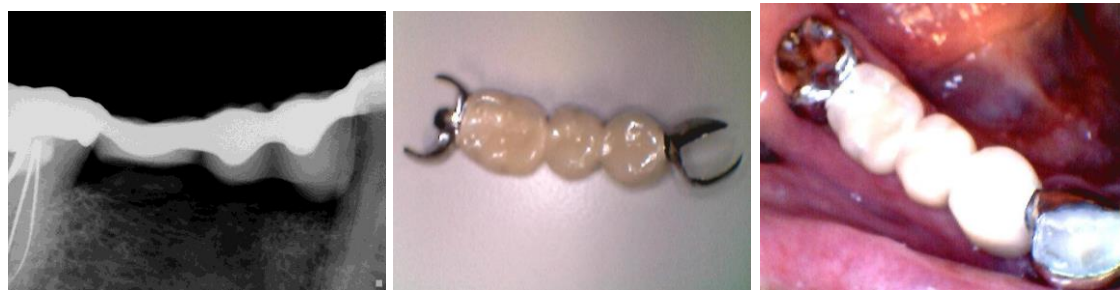
Note on all these bicuspid I chose to fully wrap the buccal and lingual with rather small occlusal rest preps. This allows for excellent grip anteriorly so that the stress breaker effect on posterior molar is practical.

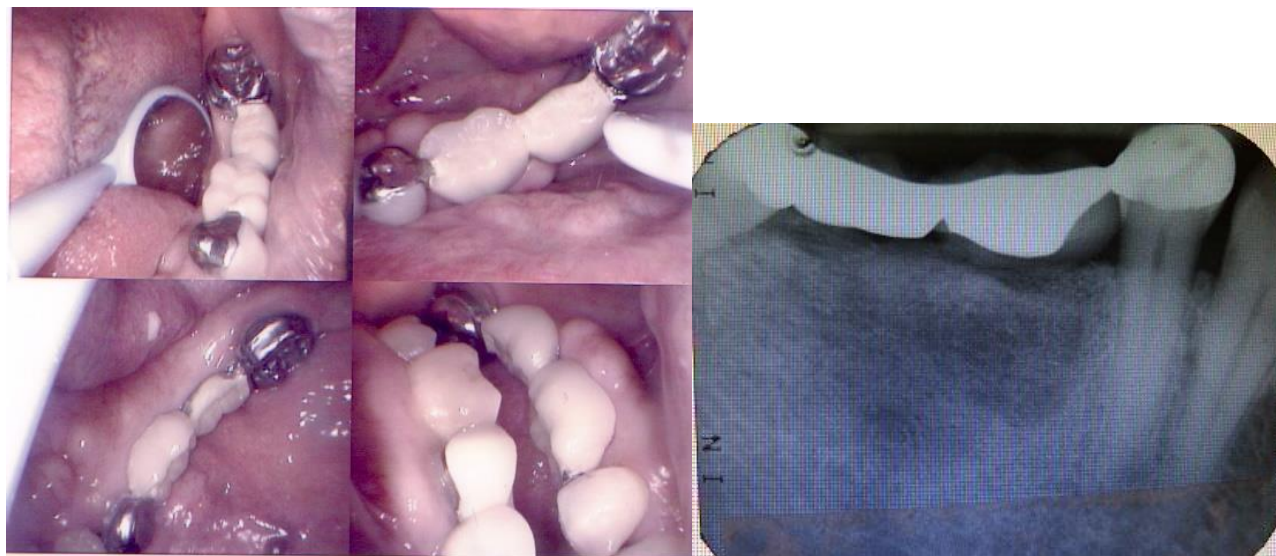
WRIGHT C.

MB #29X31 was placed 7/24/1996 and served well for 13 years until two rebonds and Alzheimer's dictated change. Patient became disabled with Alzheimer's and #32 was loose. Decided to remove and place a traditional bridge for security and ease of maintenance until deceased 10 months later. Reed Lab made bridge. Seated with Enforce bonding.
