Case Study 10

CASE REPORT – INSTALLMENT #10
Combination Bridges

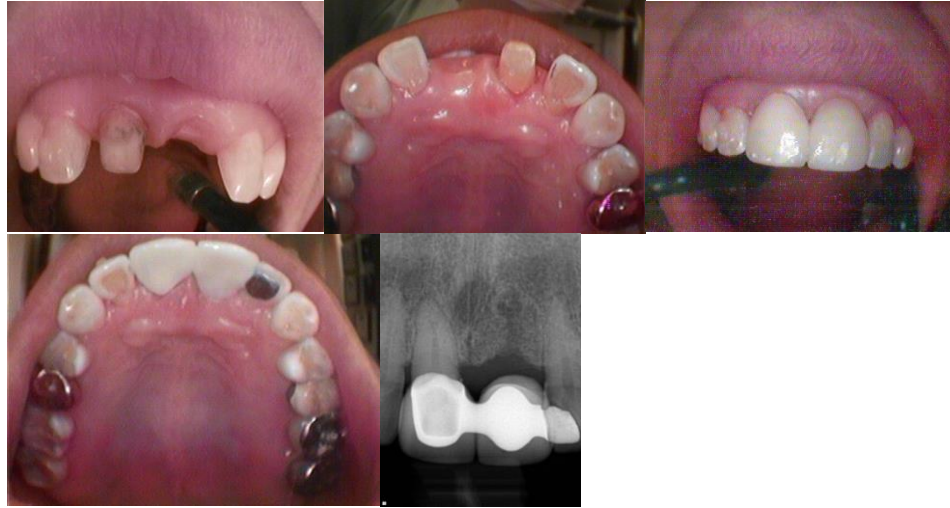
Helen K. → Anterior Combo Bridge

Patient had non-restorable #9 and old crown #8. Extracted #9, placed putty bone fill. Did clear braces for six months. Placed Combo Bridge #8 porcelain to metal crown abutment, #9 pontic, #10 MB lingual wing. Continued clear braces for 8 months additional. She has had 4 years longevity so far with great maintenance. Highland Lab.

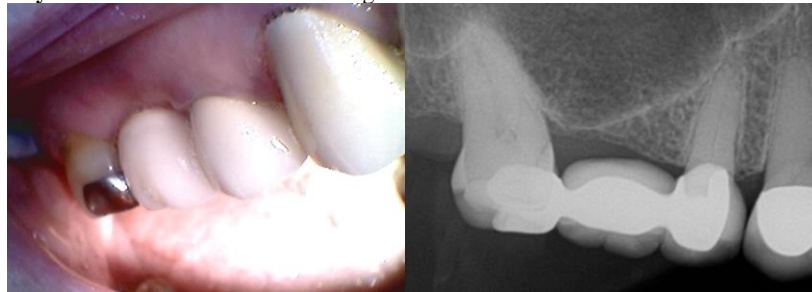
Coy R. → 4/24/07 Post Combo Bridge

#2 had old MO Amalgam changed to composite. #4 had old crown with recurrent deep decay replaced with porcelain fused to metal and #3 pontic, replacing the missing tooth #3. Nearly 8 years success/ YDL Lab.

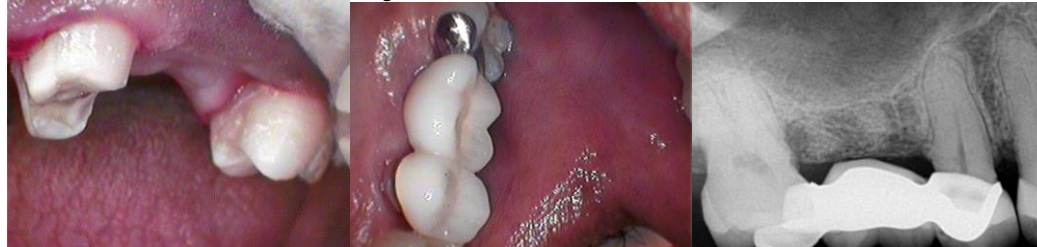
Larry B. → 1/19/12 Post Combo Bridge

#3 non-restorable was extracted and placed with bone fill with biomembrane. #2 MB wings and #4 porcelain fused to metal crown seated with #3 pontic. 4 years success thus far. Highland Lab.
